Orland Fire Station Committee

Final Report to the Town of Orland Selectmen

FACILITY ASSESSMENT OF ORLAND FIRE STATION

Prepared for:
Town of Orland, Maine
November 26, 2019

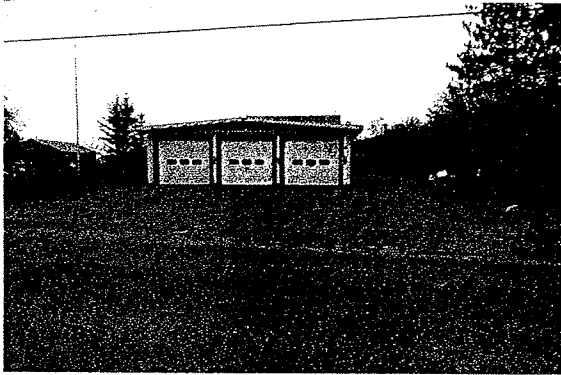
The entire site around the perimeter of the fire station and rear addition is too low to allow for proper drainage. The entire site needs to be regraded to drain away from the buildings and a full-depth catch basin and underdrain system is recommended.

3.1.A Westerly side of fire station

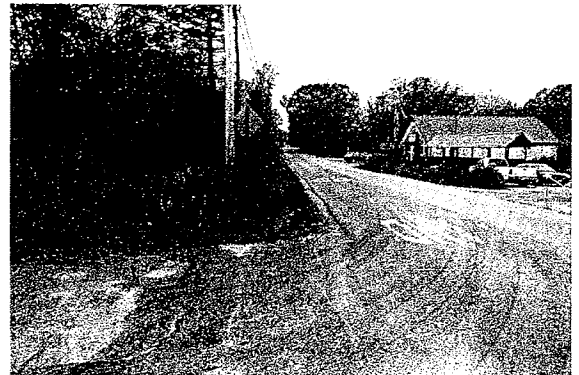
3.1.A Existing conditions southerly of site

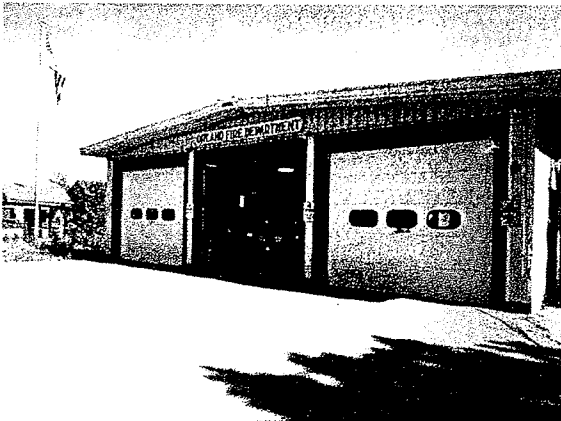
3.1.B Westerly side of fire station

- B. Regrade the driveway at the front/westerly side of the fire station all the way to the road in order to provide positive drainage away from the building. Excavate the existing pavement and gravel material and install crushed, screened gravel, meeting Maine Department of Transportation (MaineDOT) specifications, over geotextile fabric; proposed underdrain along the westerly face of the building will be installed as part of the catch basin underdrain system noted above; additionally, to further minimize frost heaving at the overhead doors, install high density rigid insulation within the gravel layers. Repave the area. (See photos 3.1.B)

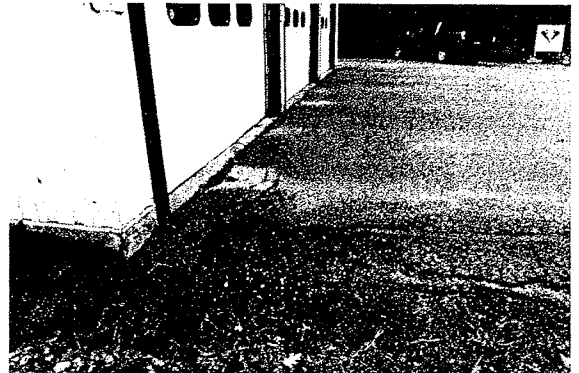
3.1.B Existing settlement at OH doors

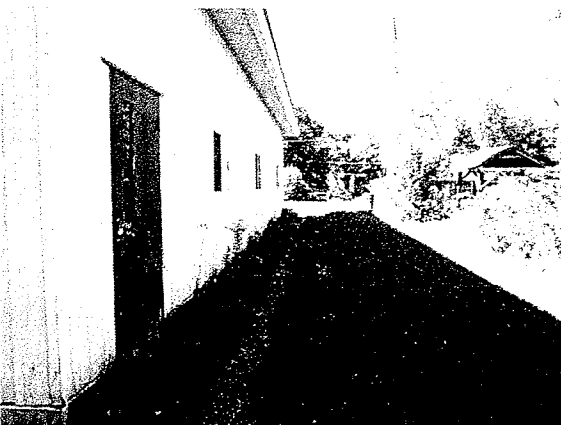
3.1.C Northerly side of fire station

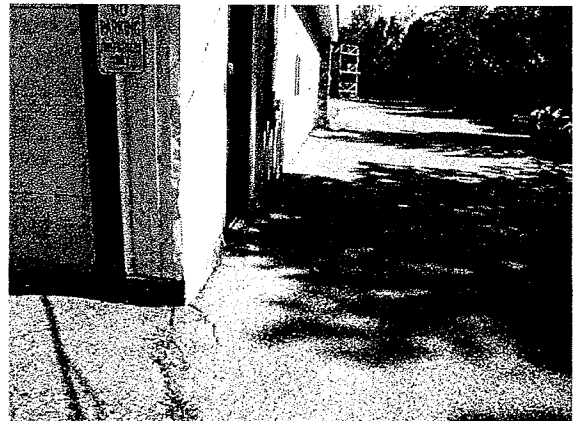
3.1.C Southerly side of fire station/addition

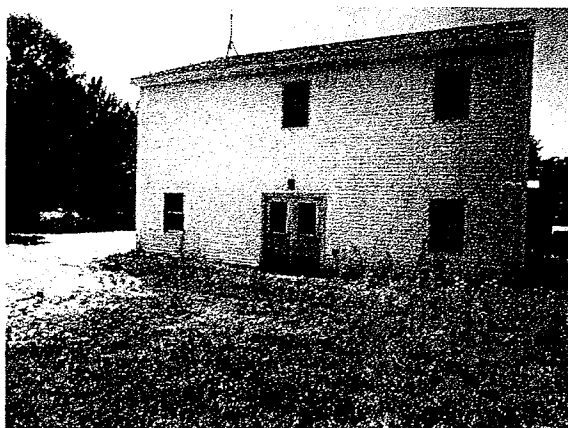
3.1.C Easterly side of rear addition

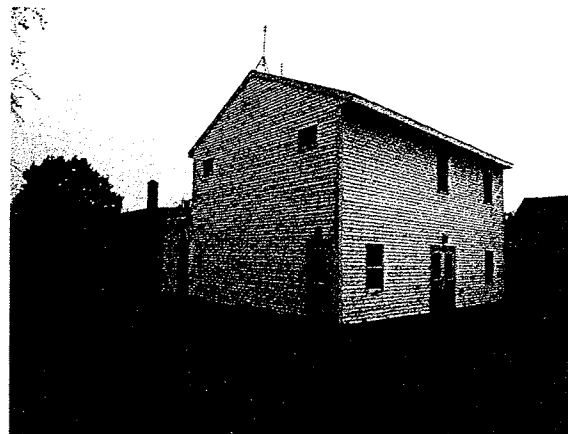
3.1.D Southerly & easterly sides of buildings

3.1.D	Pave southerly, easterly sides of fire station and rear addition	\$30,000	4
3.2.F	Repair ceilings/walls in restroom/utility	\$1,000	4
3.2.G	Install wall/ceiling insulation	\$45,000	4

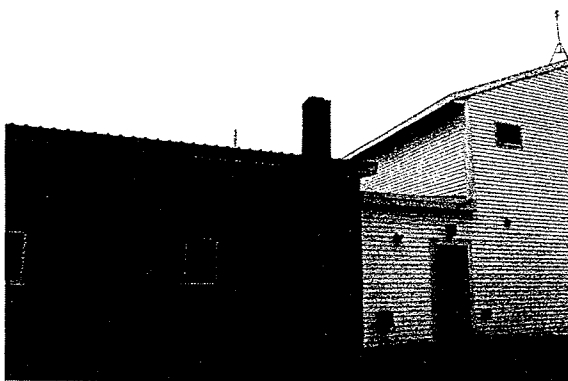
- C. The abandoned masonry chimney is in poor condition and is a potential safety hazard. Remove the abandoned chimney and patch the wall. (See photo 3.2.C)

3.2.C Abandoned chimney

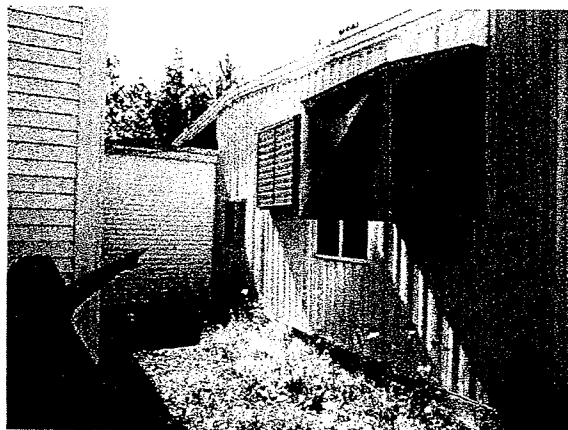
- D. The original building exhaust system is not functional and is a source of air and water leaks. Remove it and patch the wall. (See photo 3.2.D)

3.2.D Building exhaust

3.2.B	Replace metal roof and siding	\$40,000	3
3.2.D	Remove building exhaust system	\$4,000	3
3.2.K	Replace lights; add new lights & receptacles	\$12,000	3
Priority 3 (Necessary; not yet critical) Total		\$56,000

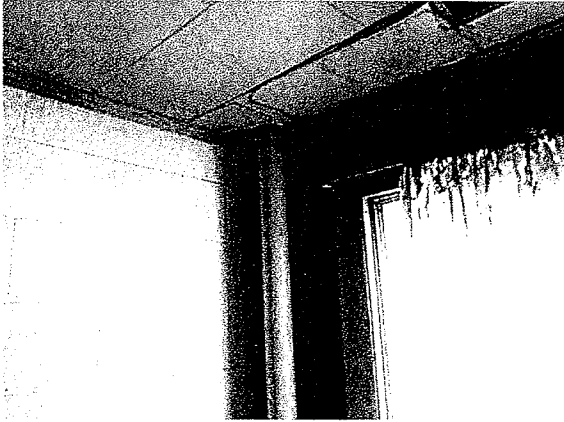
- F. The ceilings and walls in the restroom and utility space have damage. Repair and refinish as needed. (See photo 3.2.F)

3.2.F Restroom damage

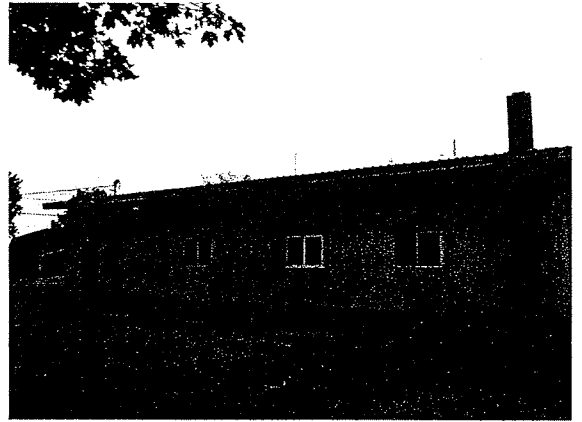
- H. The windows are in poor condition and the man doors are in fair to poor condition. Replace the doors and windows. (See photo 3.2.H)

3.2.H Windows and doors

3.2.H	Replace doors and windows	\$12,000	4
3.2.J	Replace overhead doors and motors	\$18,000	4
Priority 4 (Recommended) Total		\$106,000	
3.1.F	Install ADA handicap parking spaces	\$5,000	5

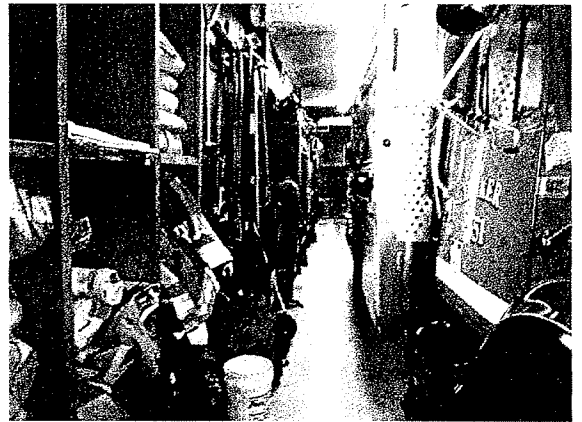
- I. There is inadequate space in the existing fire station building. Some equipment is stored in sheds out back. There is no wash down area for firemen and equipment, very limited storage, and limited area for movement between vehicles. Add a 12-foot by 60-foot addition with overhead door to the northerly side of the building. (See photos 3.2.I)

3.2.I Lack of space

3.2.A	Repair floor drains, install oil/water separator	\$26,000	2
3.2.I	Construct addition to fire station	\$54,000	2
3.3.C	Raise floor of rear addition	\$36,000	2
Priority 2 (Potentially Critical) Total		\$116,000

- The facility assessment recommends constructing a 12' x 60' building addition on the north side of the fire station to address inadequate space. Upon further review, there is insufficient room between the adjoining property line and the fire station for the recommended addition.

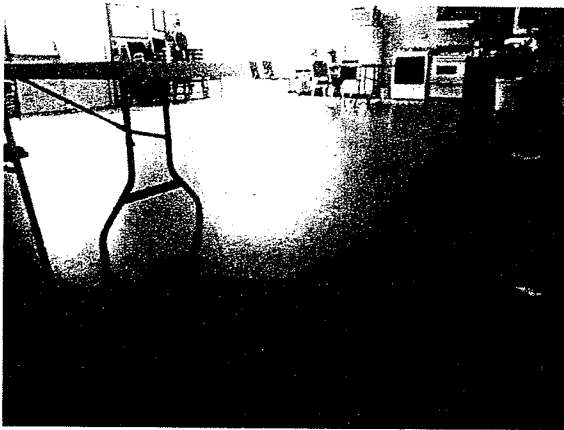
- C. The first floor periodically floods due to the low elevation of the floor relative to the outside grades. Flooring is damaged. Wall construction is wood frame with interior GWB that is susceptible to water damage and potential mold growth. Grading options are very limited for this portion of the building and raising the floor level is recommended. Remove existing flooring and install a new 7-inch concrete floor to match stair tread. Raise exterior and interior doors. Notch out walls to remove water and/or mold damage, and to fit onto the raised concrete. Install new flooring. The regrading around the building to improve drainage is covered with site items noted above. (See photo 3.3.C)

3.3.C Floor damage at rear addition

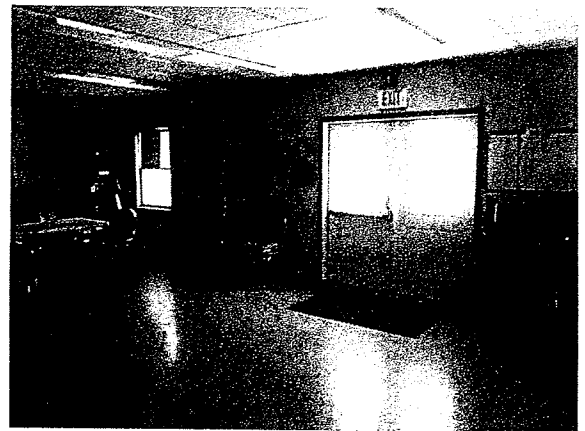
3.3.D Fire alarm pull station next to door

3.3.B	Repair leak in electrical conduit	\$4,000	1
3.3.D	Replace alarm panel, tie in all pull stations	\$26,000	1
Priority 1 (Currently Critical) Total		\$294,000
